# VEHICLE INSPECTION REPORT

**BF23YOC**

## Iveco Eurocargo 120-210

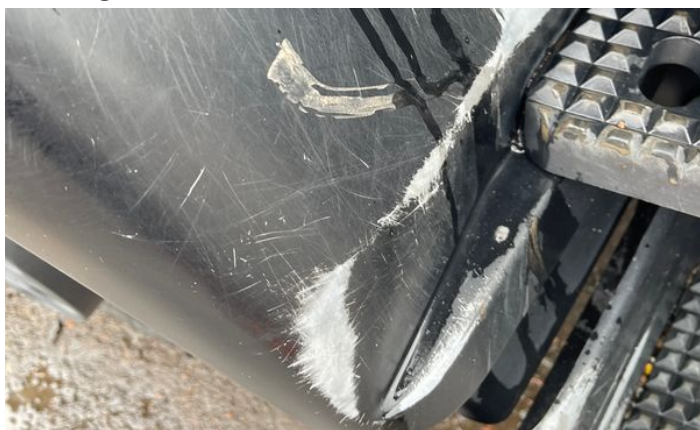
1: Door Moulding of  
Scuffed (Unpainted)  
Over 100mm

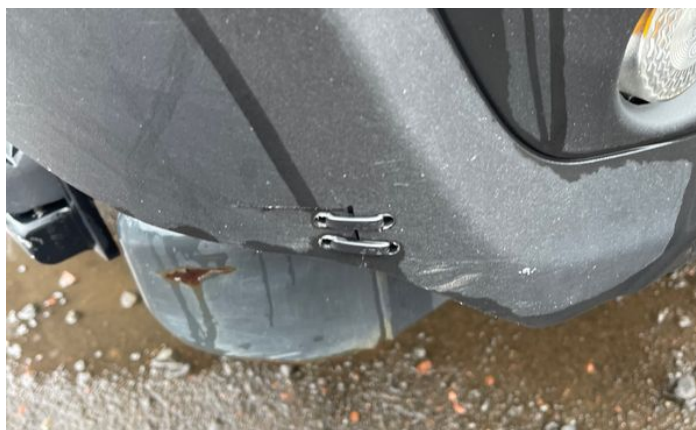
2: Bumper Front Moulding  
Scuffed (Unpainted)  
Up To 100mm

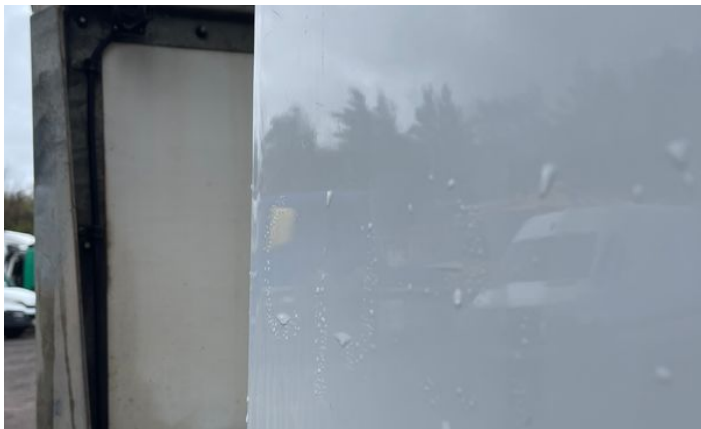
3: Door osf  
Dented  
Over 30mm

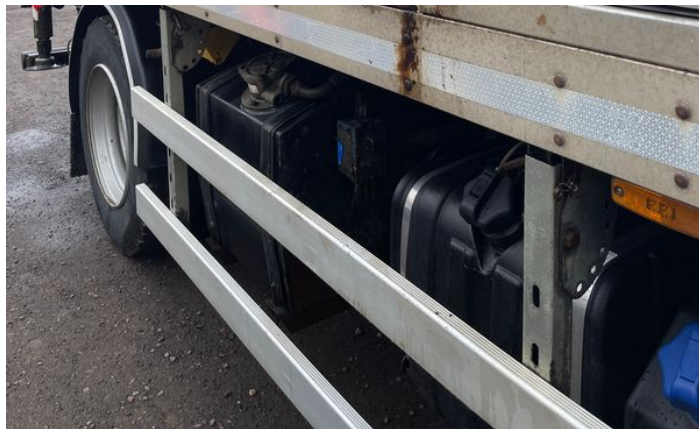
4: Qtr Panel osr  
Rusted  
Over 5mm

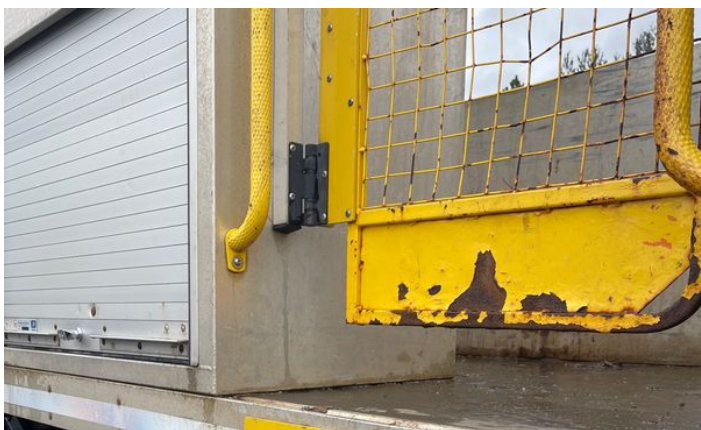
5: Qtr Panel nsr  
Scratched  
Over 25mm Thru Paint

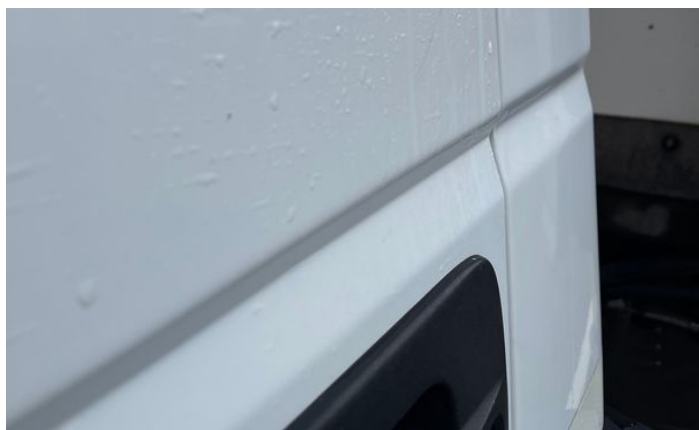
6: Door nsf  
Dented  
Over 30mm

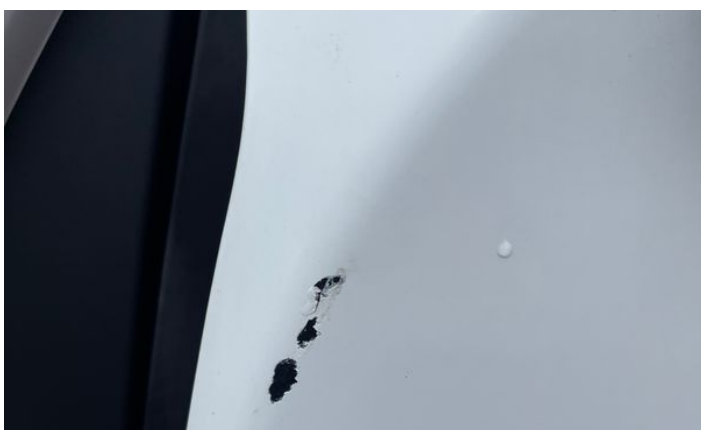
7: Wing nsf  
Chipped  
Over 5mm
