VEHICLE INSPECTION REPORT

Land Rover Defender 110 2.2 TDCI

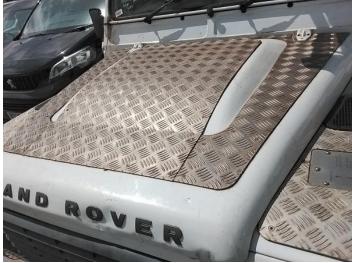
2: Bonnet Dented Over 30mm

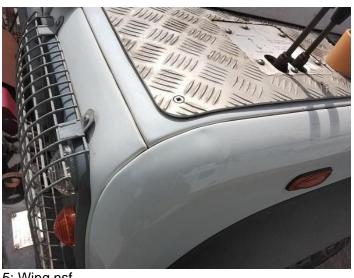
3: Bonnet Scratched Over 25mm Thru Paint

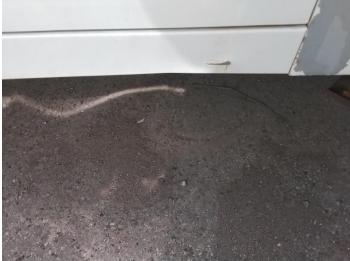
8: Door nsf Dented Over 30% Of Panel

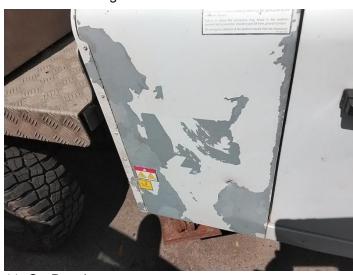
9: Sill ns Dented With Paint Damage

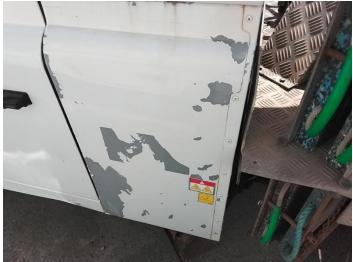
11: Qtr Panel osr Scratched Over 25mm Thru Paint

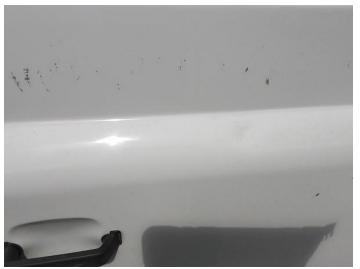
10: Qtr Panel nsr Scratched Over 25mm Thru Paint

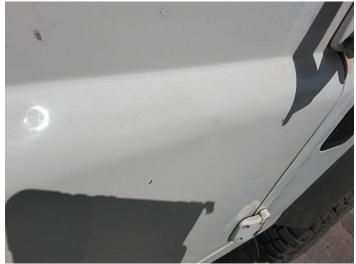
12: Door osf Dented Over 30mm

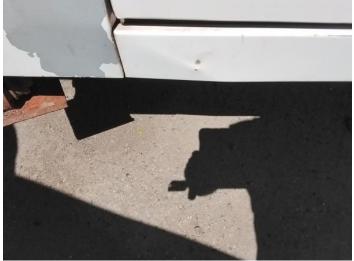
13: Door osf Dented Over 30mm

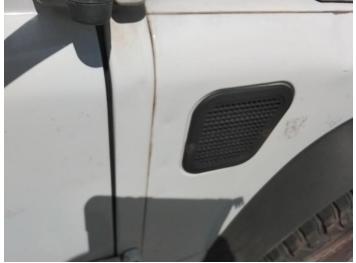
14: Sill os Dented With Paint Damage

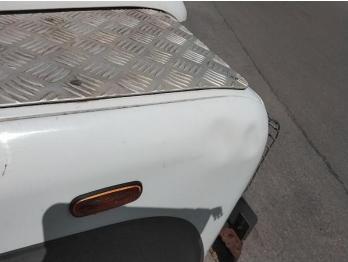
15: Wing osf Dented Over 30mm

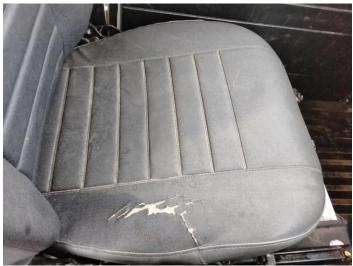
19: Seat Base Cover osf Torn Over 3mm
